2023 Hail Impact Research and Testing

Rich Koziol, Heidi Mase, Corrie Piehowski, & Pat Shaughnessy
Wiss, Janney, Elstner Associates, Inc.

- Determine the extent of damage caused by hail impact to granular surfaced, modified bitumen membrane of various ages through physical testing and laboratory review and analysis.

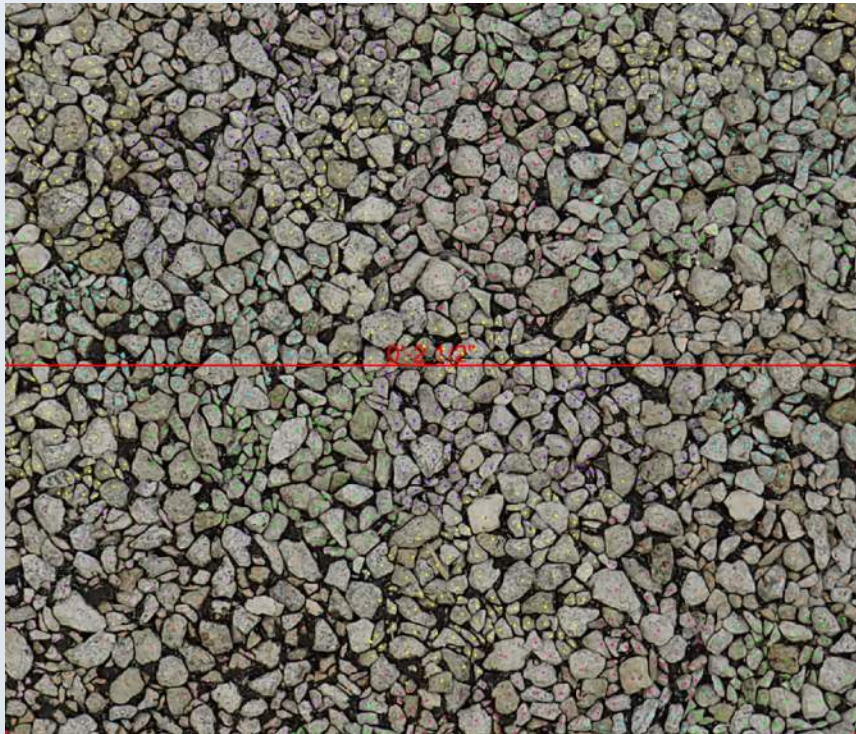
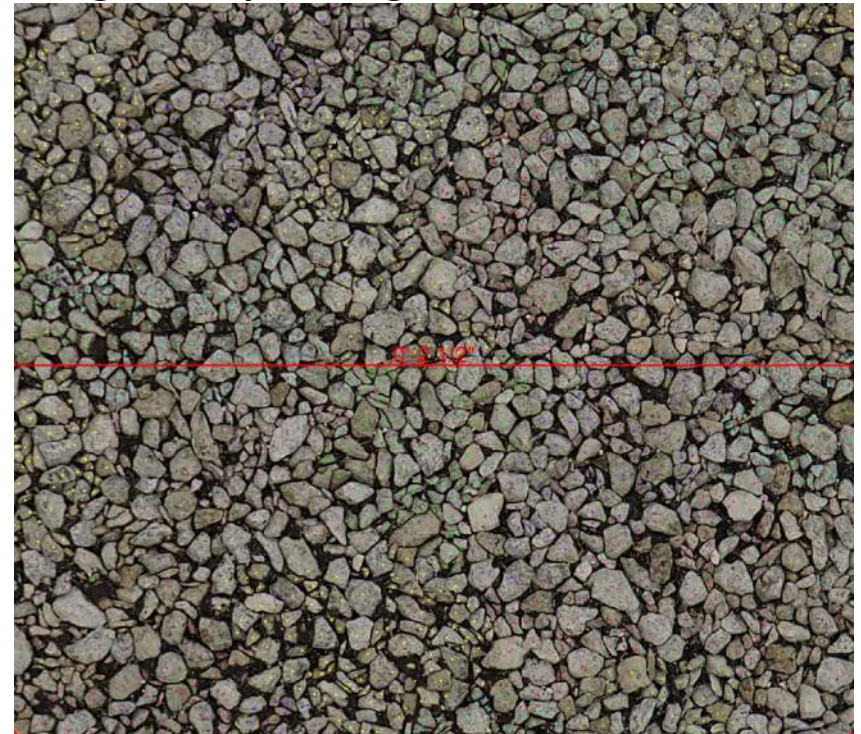
N-MB-G-1. Not much noticeable change; very few granules lost

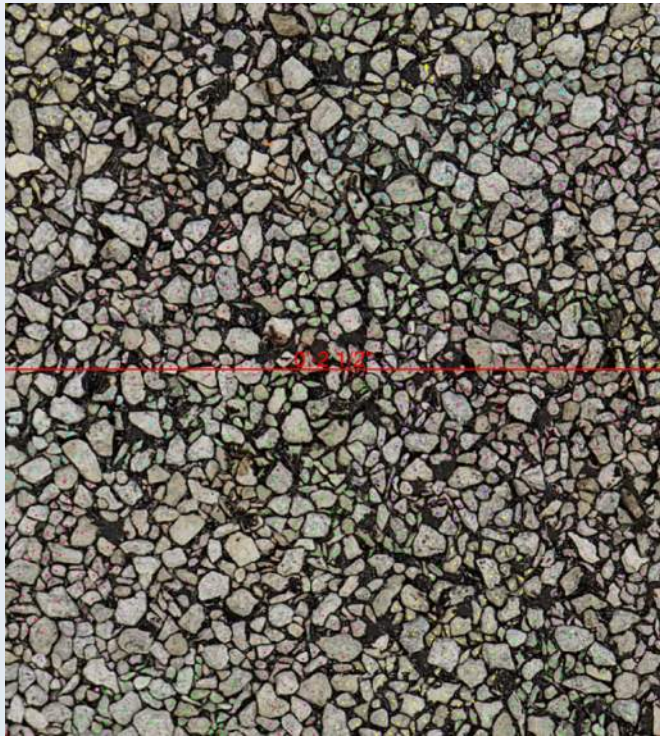
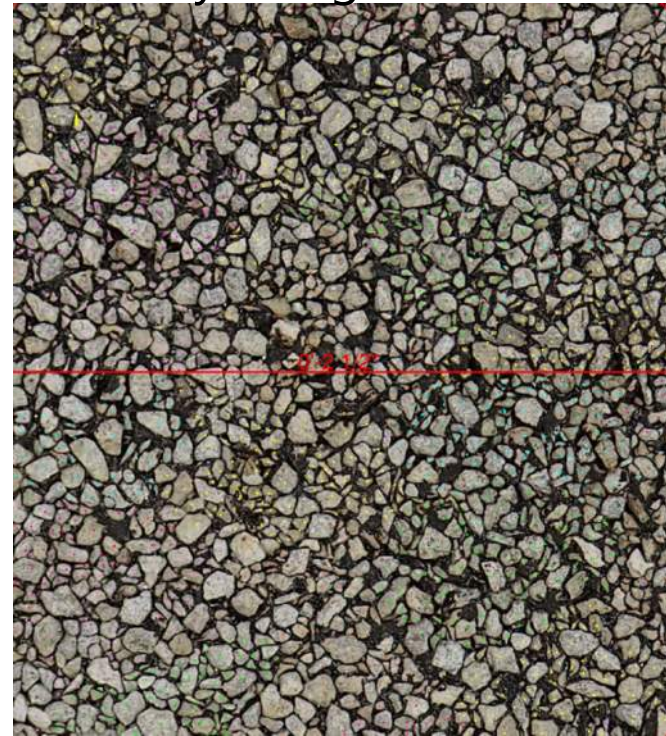
N-MB-W-1. Not much noticeable loss; very few granules lost

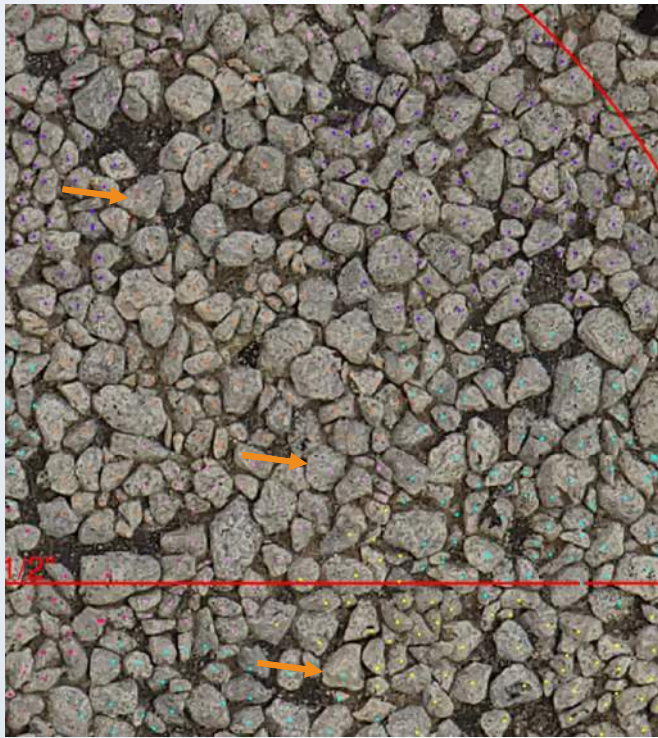
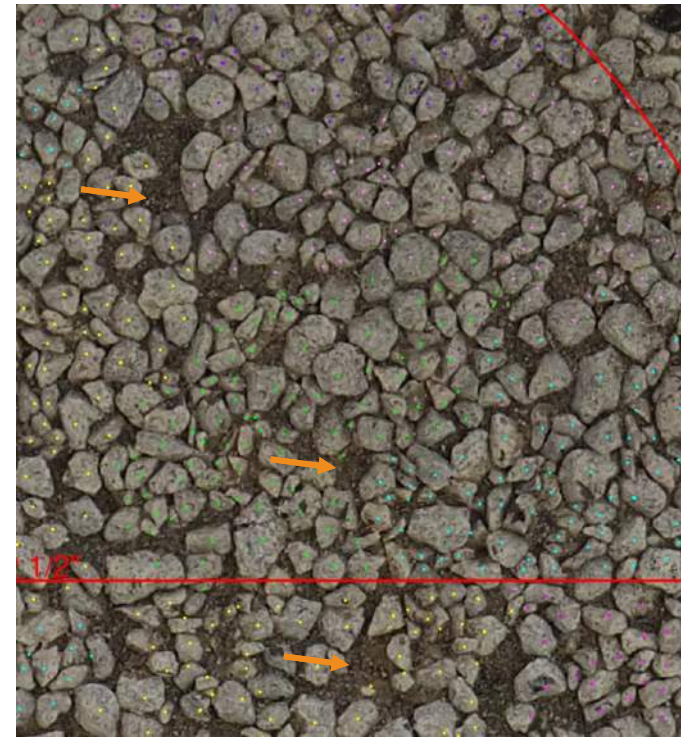
5-MB-G-1. Areas with fewer granules are visible, but still few lost

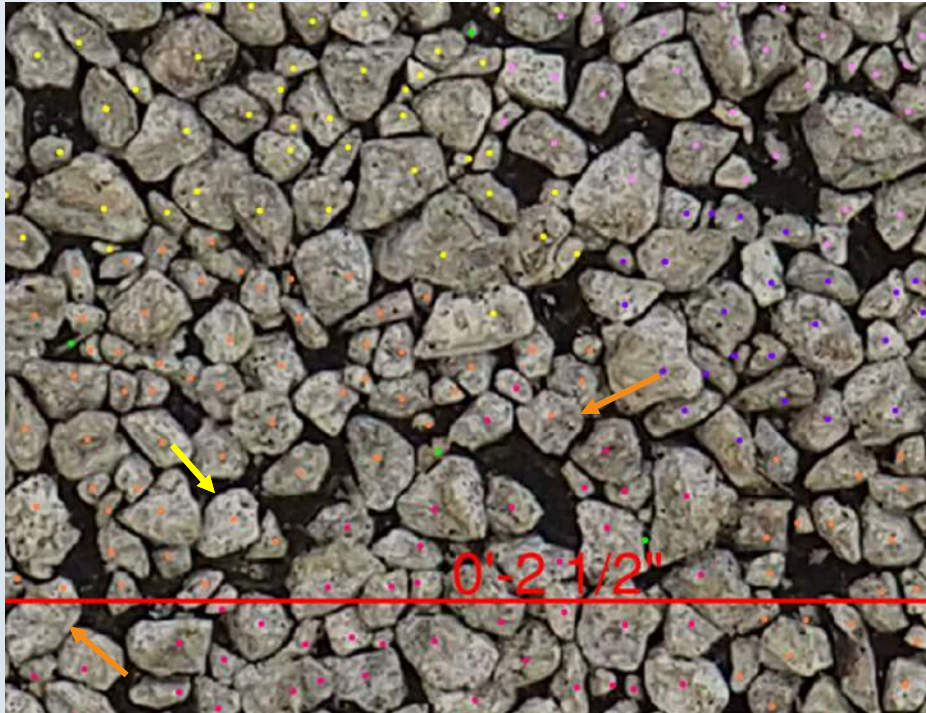
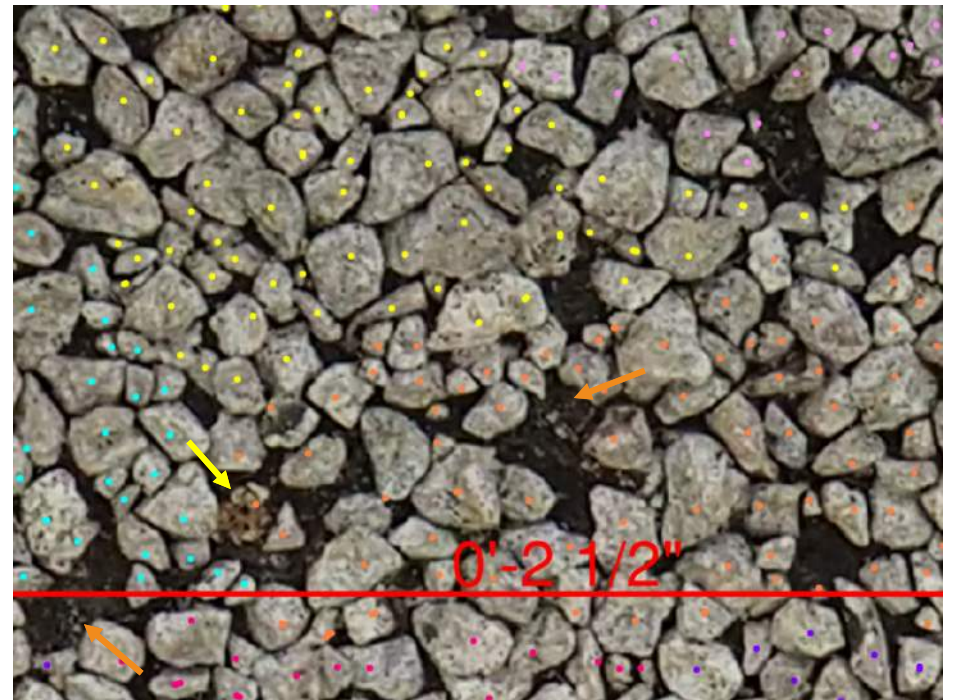
5-MB-W-1. Areas with fewer granules are visible, some cracked or removed

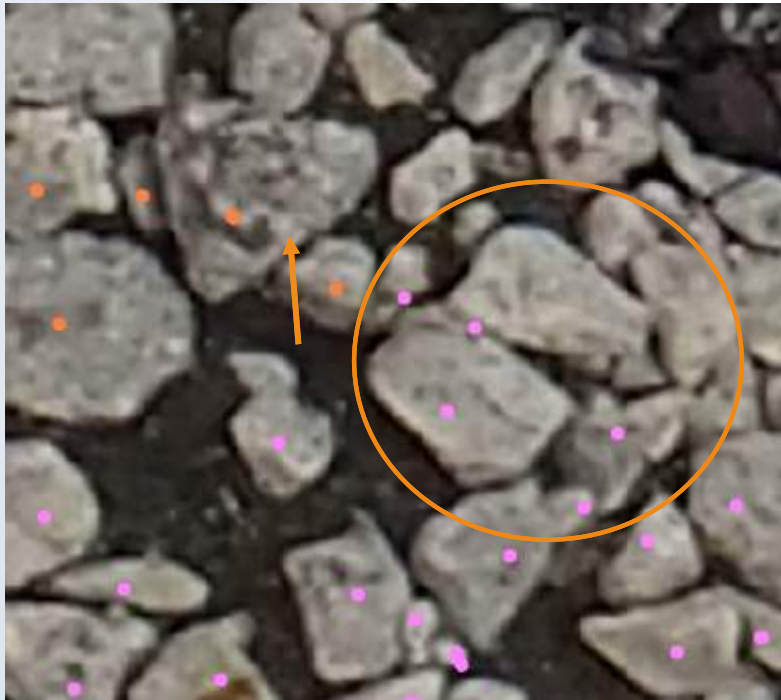
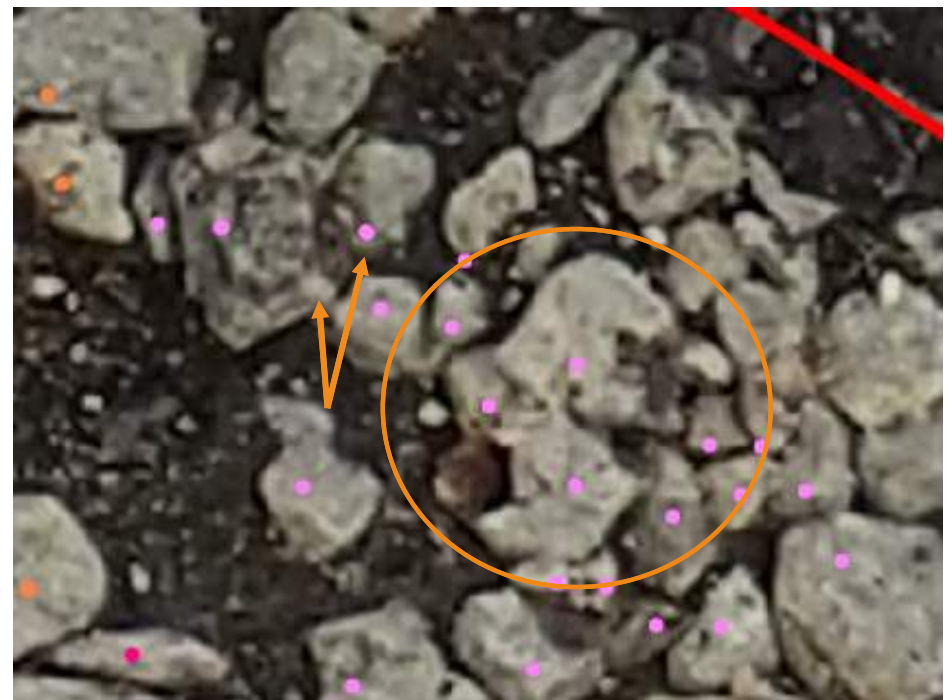
10-MB-G-1. Granules breaking or changing shape, resulting in more granules

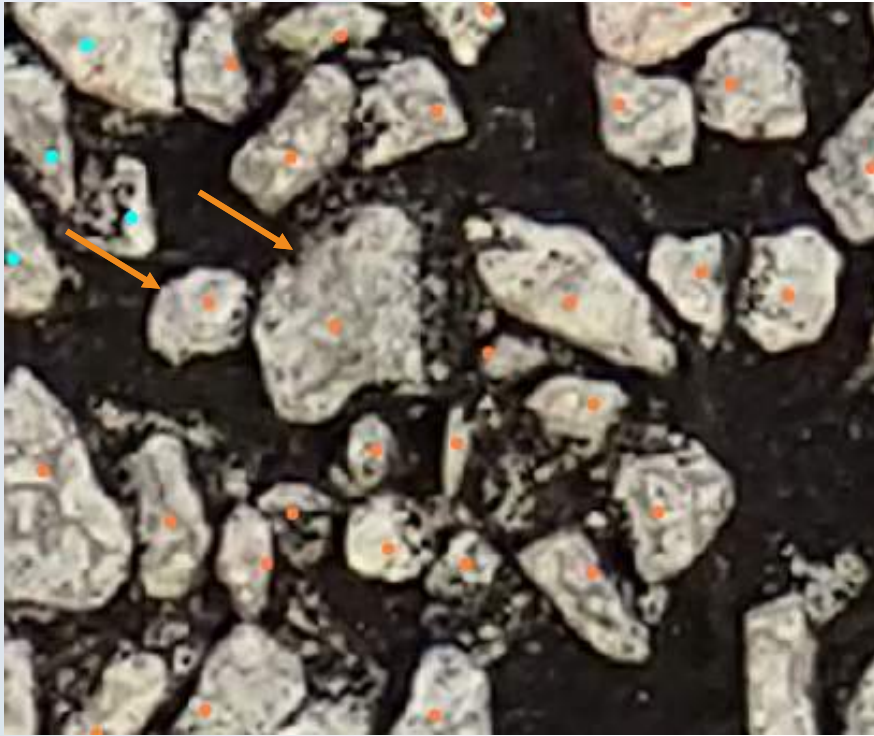
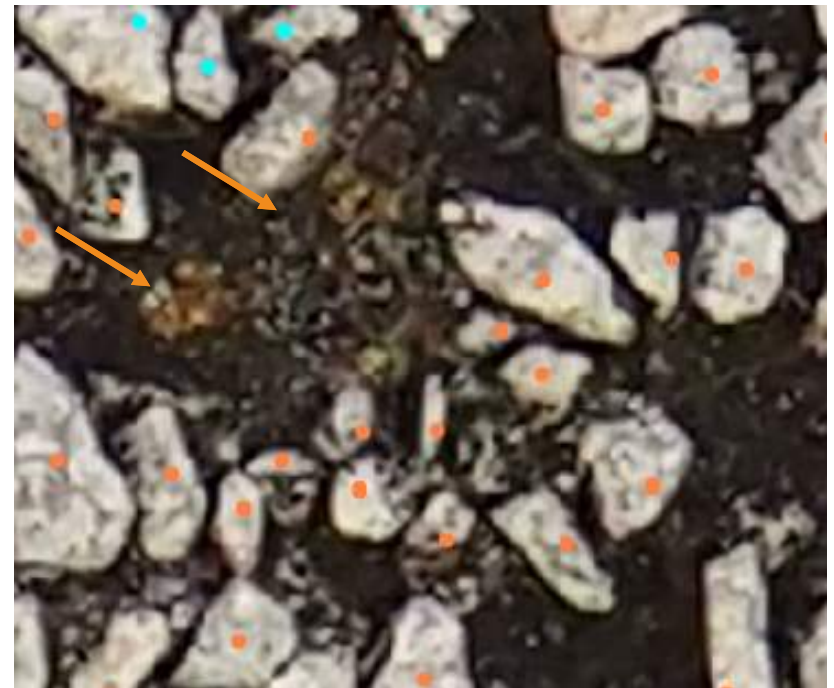
10-MB-W-1. Granules breaking or being crushed, in addition to loss

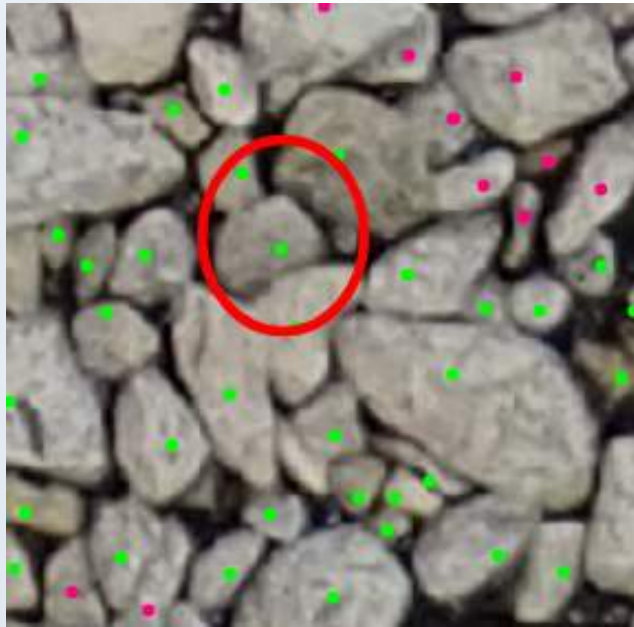
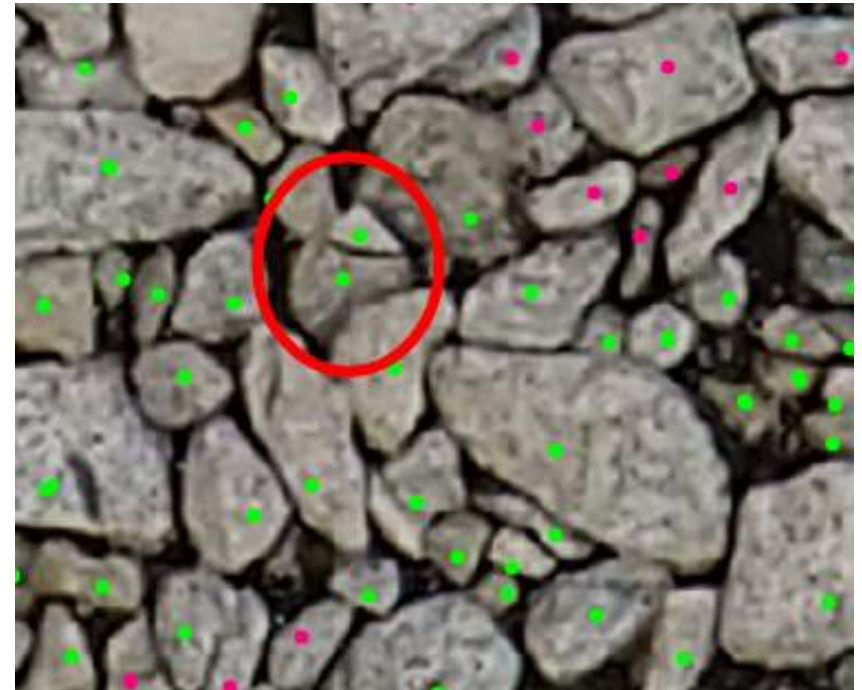
N-MB-W-3. Cracking of granules observed

**Higher granule count due to cracking of granules

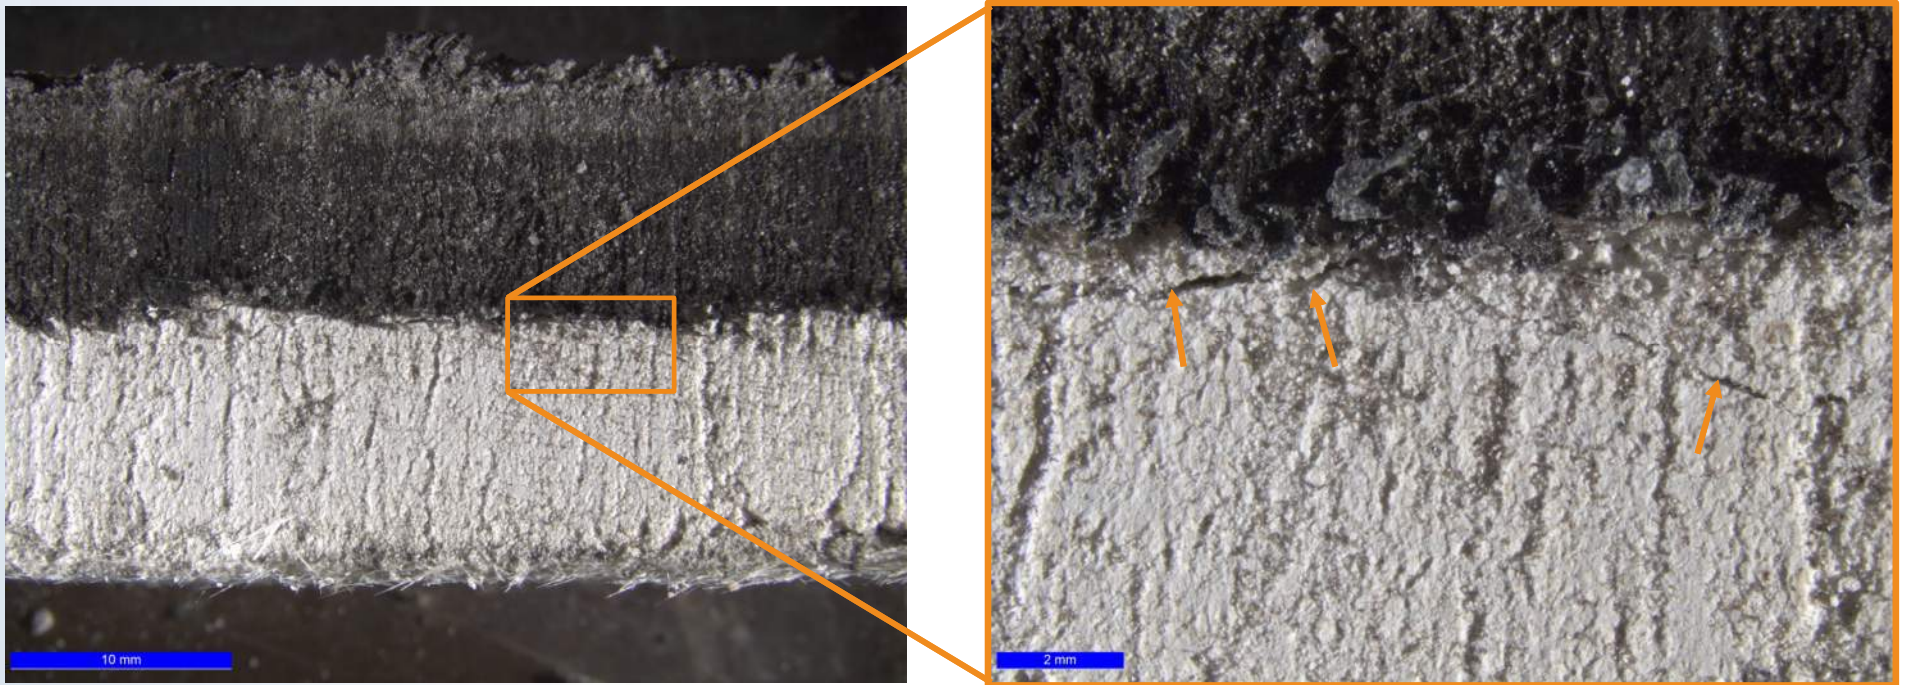
5-MB-G-1- Surface-parallel cracking just below surface of gypsum; potential radial cracking, too fine to determine if radial cracks are full depth of gypsum

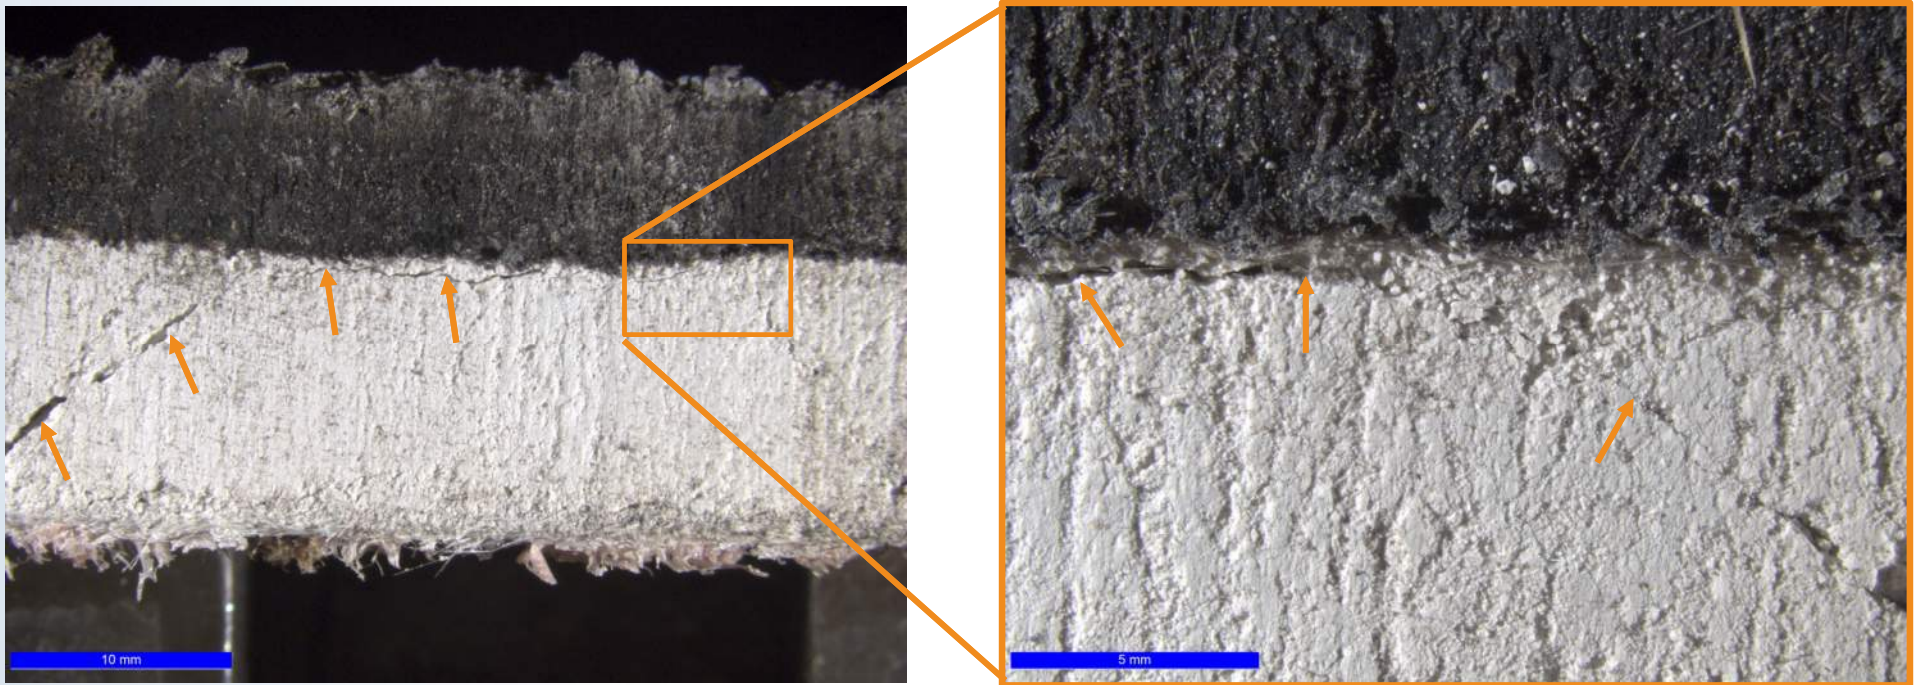
10-MB-G-3- Full separation of gypsum and bitumen at interface; radial cracking extending full depth of gypsum from impact site

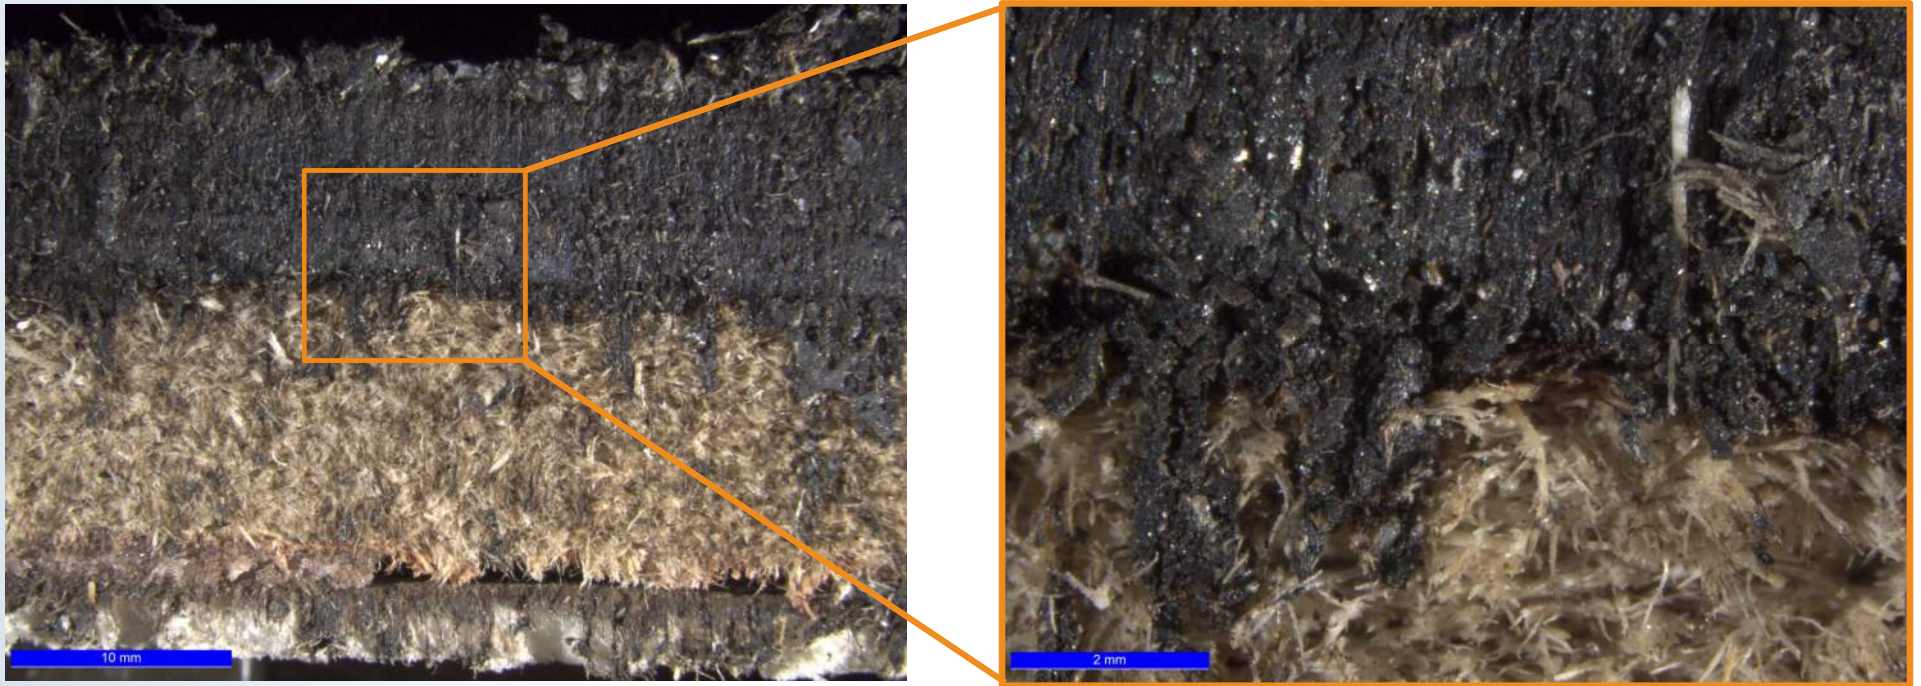
N-MB-W-1- No visible cracking or separation of the asphalt from the wood fiber board

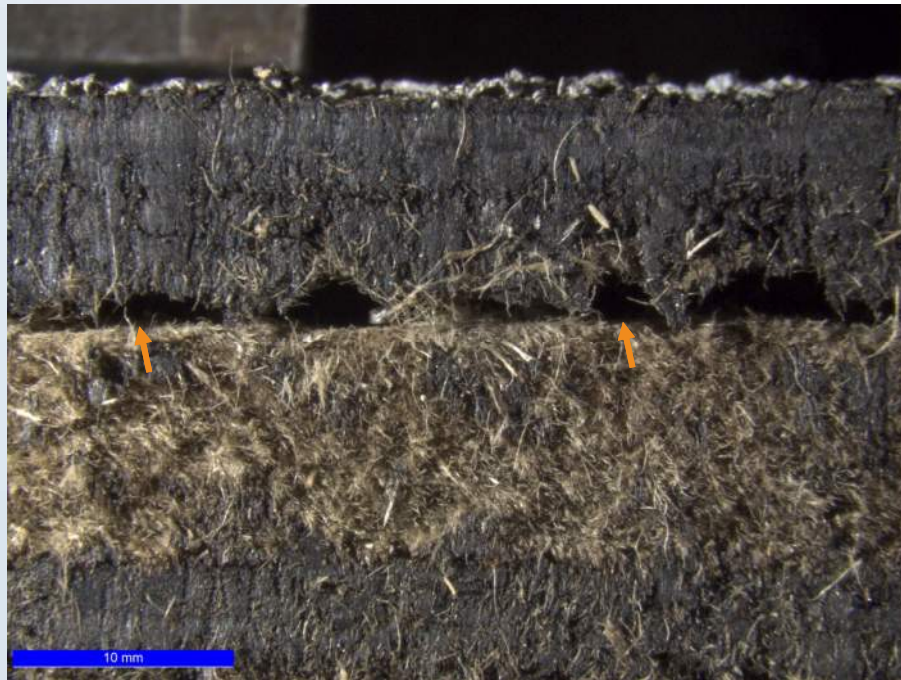
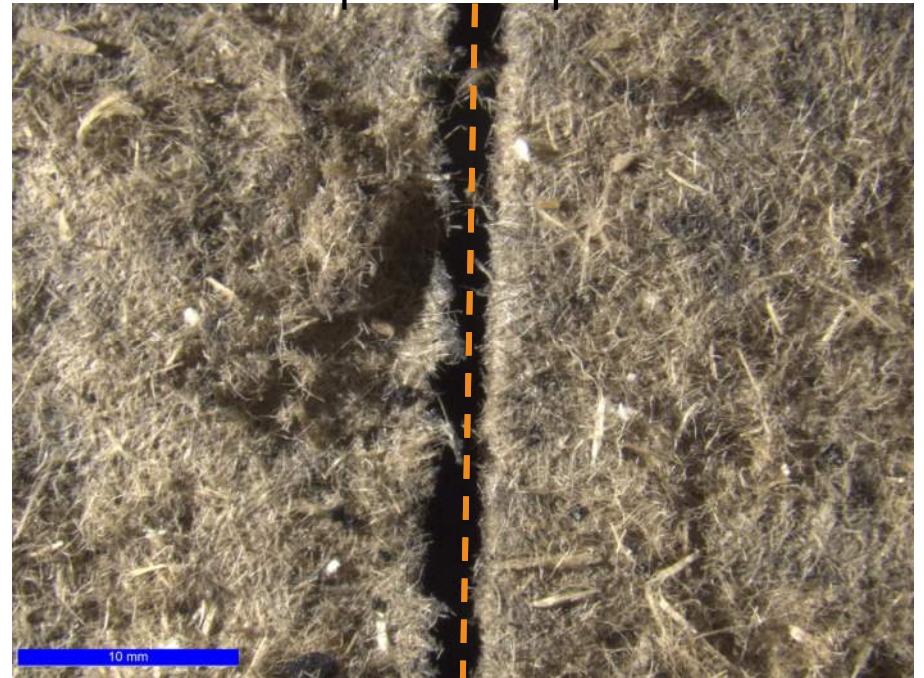
10-MB-W-2- Full separation of the asphalt from the wood fiber board on one half of observed area

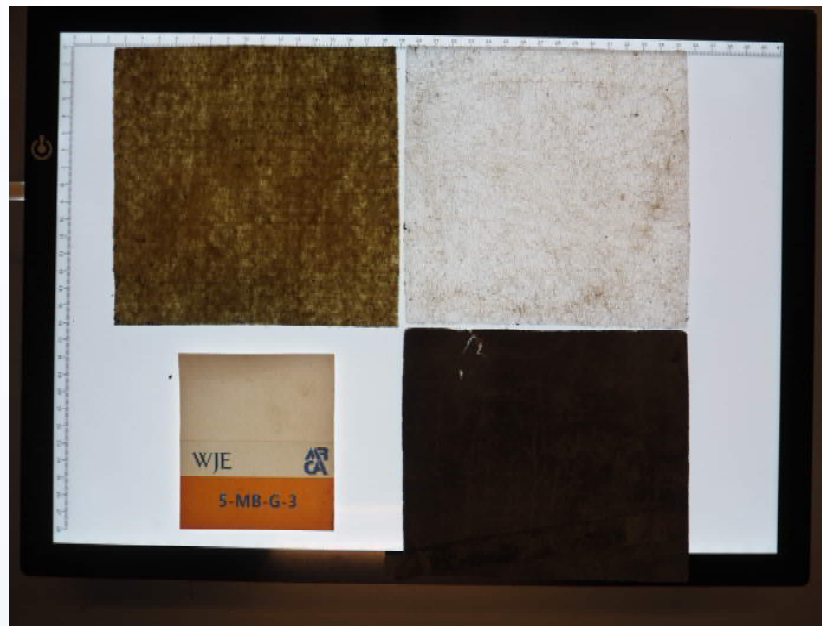
- Impacts did not fracture membrane reinforcement.

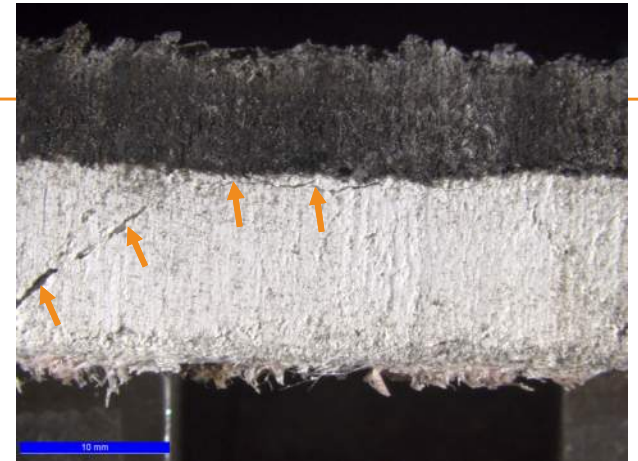
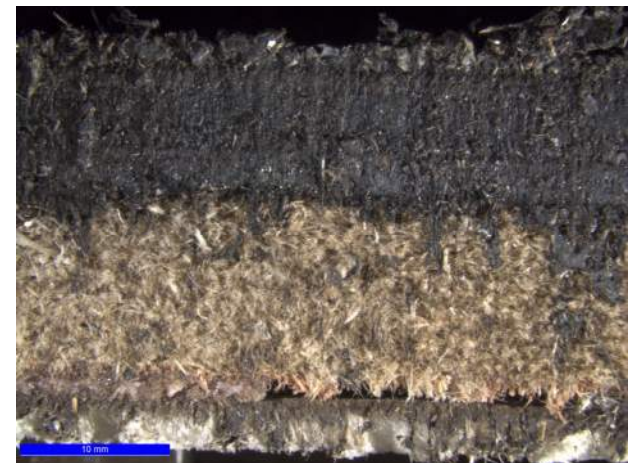
- Impact causes facer separation from gypsum core at impact sites with gypsum cover board.
- Cracking of the gypsum cover board was observed at the impact site.
- Wood fiber cover board generally appeared to be unaffected by impact.
