2023 Hail Impact Research and Testing

Rich Koziol, Heidi Mase, Corrie Piehowski, & Pat Shaughnessy
Wiss, Janney, Elstner Associates, Inc.

- Determine the extent of damage caused by hail impact to granular surfaced, modified bitumen membrane of various ages through physical testing and laboratory review and analysis.

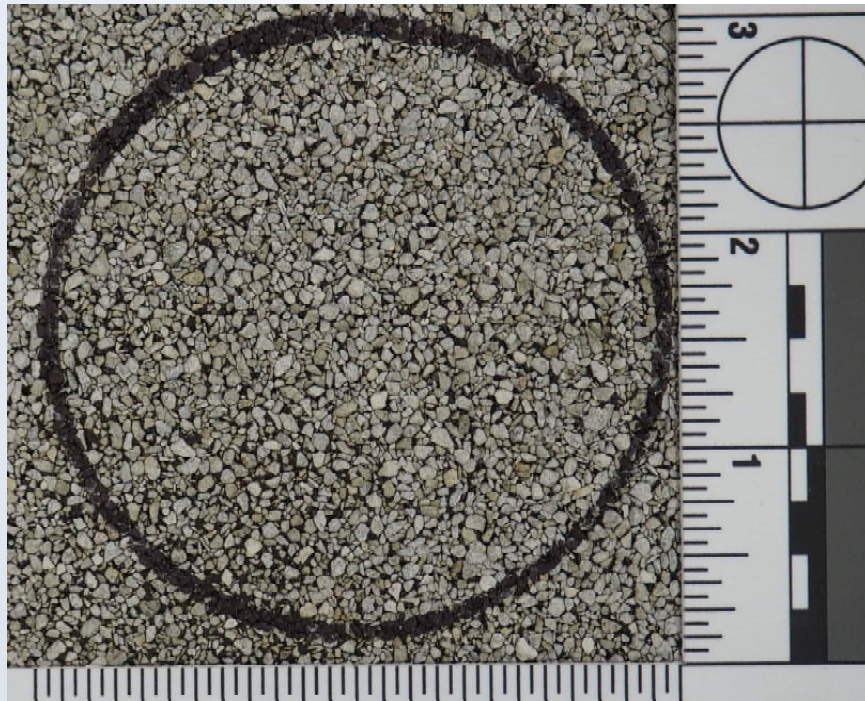
N-MB-G-1

Pre-impact

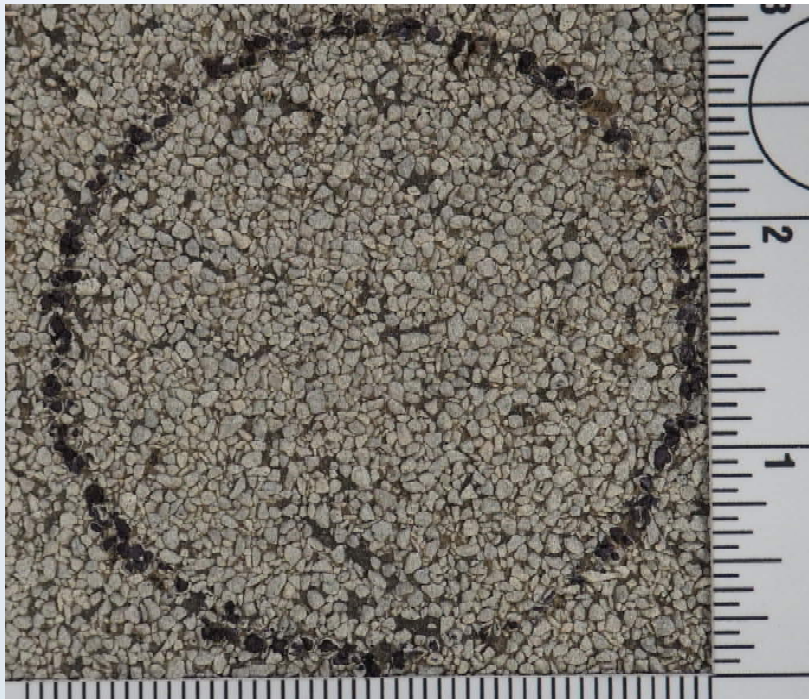
5-MB-G-1

5-MB-G-1. Areas with fewer granules are visible, but still few lost

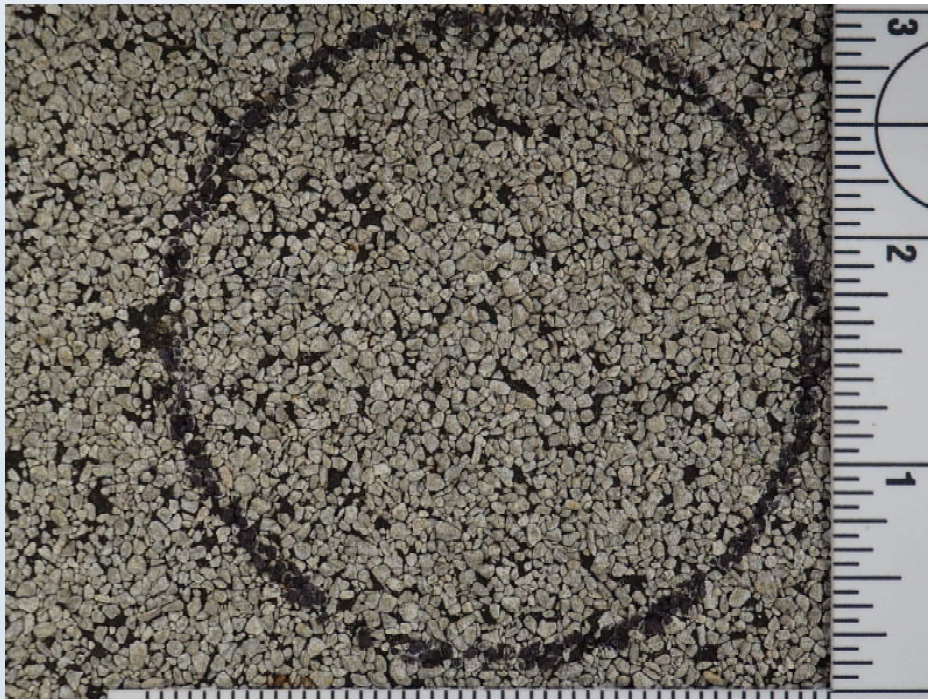
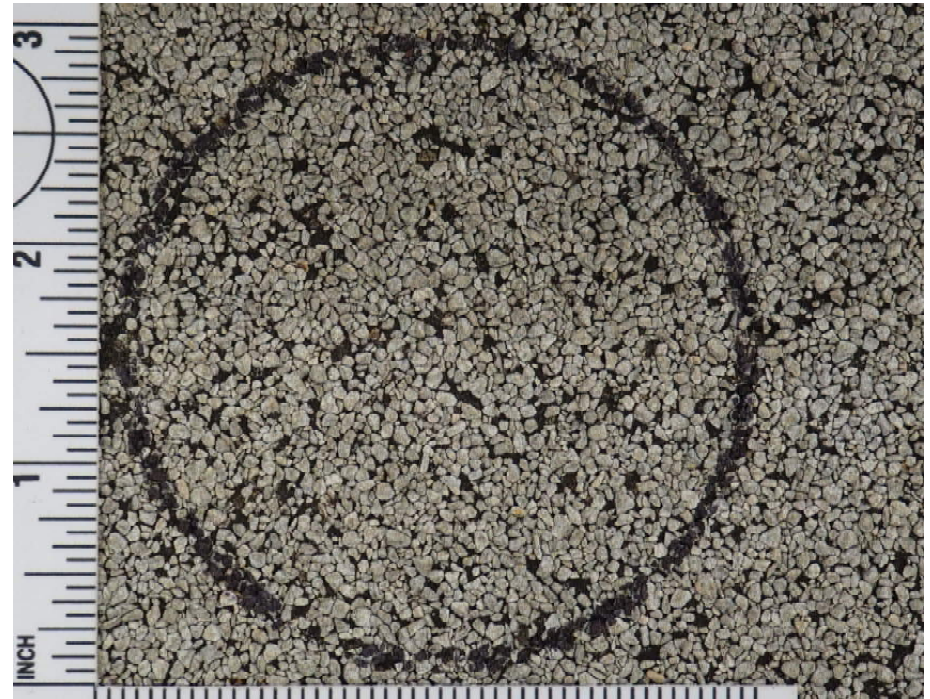
5-MB-W-1

5-MB-W-1. Areas with fewer granules are visible, some cracked or removed

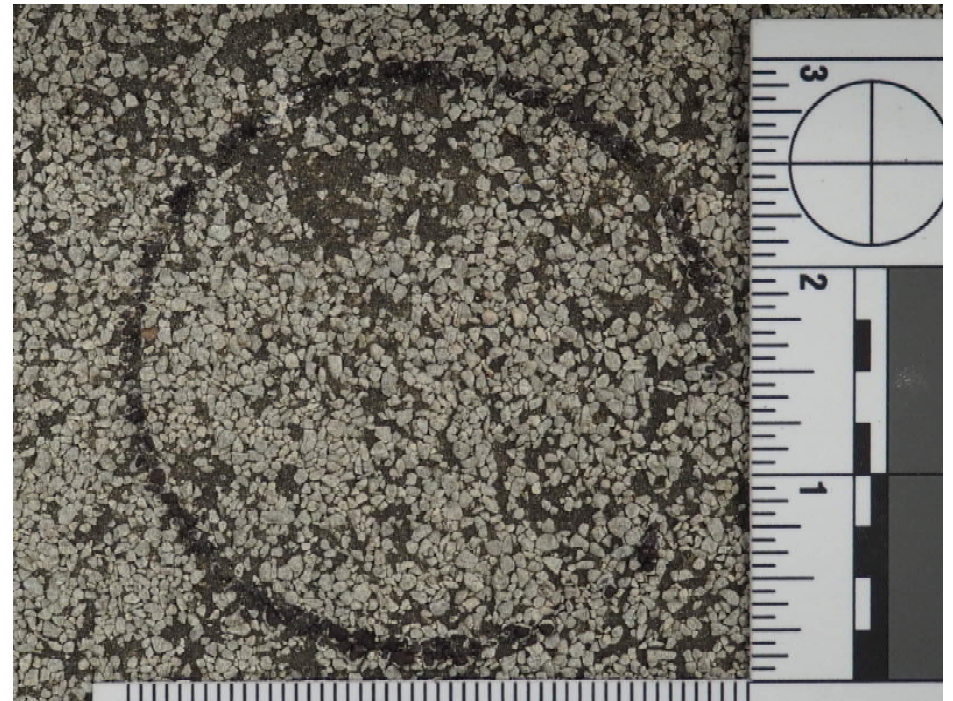
10-MB-G-1

10-MB-G-1. Granules breaking or changing shape, resulting in more granules

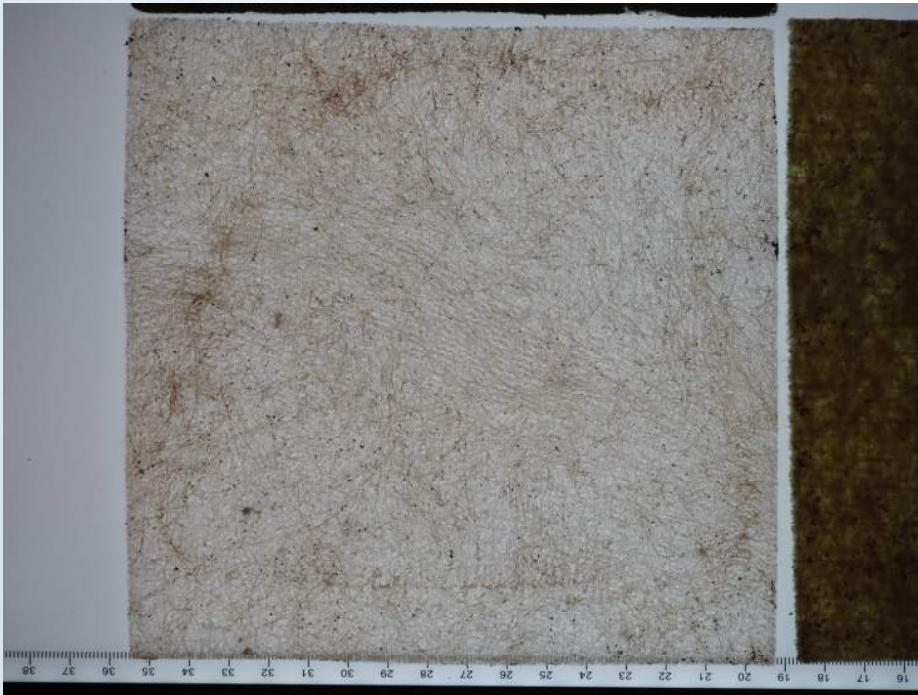
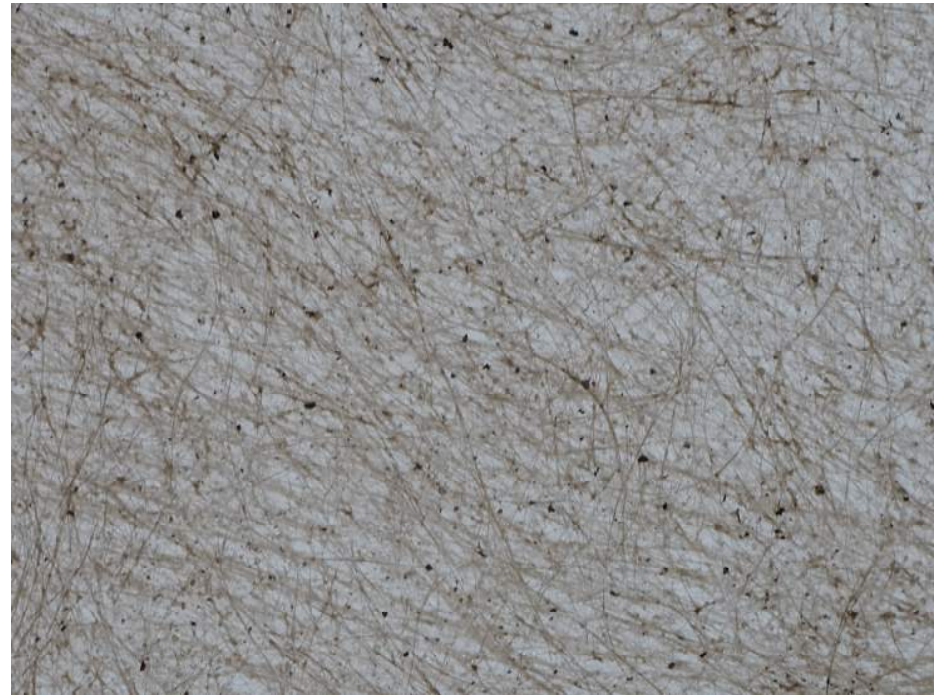
- Base sheet - fiberglass reinforcement

- Impacts did not fracture membrane reinforcement.
